**TECHNICAL BULLETIN NUMBER 005-2009**

**MODEL: Stelvio 1200 NTX**

**SUBJECT: Wheels and knobbly tyres**

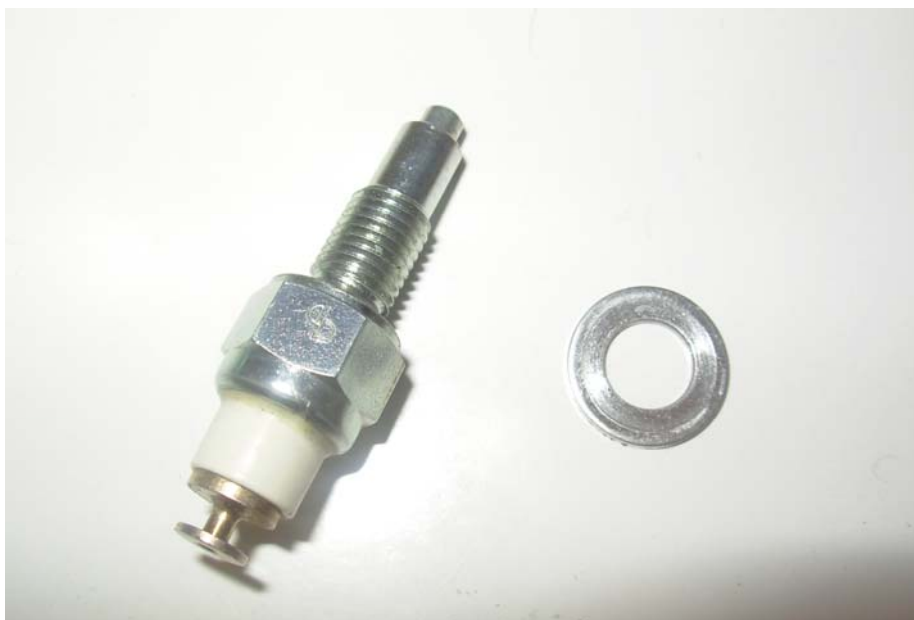
please note that each time the neutral sensor code GU19207220 is replaced the relative washer GU12154200 must also be replaced to ensure the correct functional tolerance is maintained.

It is also advisable to tighten sensor to the torque prescribed by the workshop manual:

- 10 Nm for all the engines 1100 – 1200
- 8 Nm for engines 750.

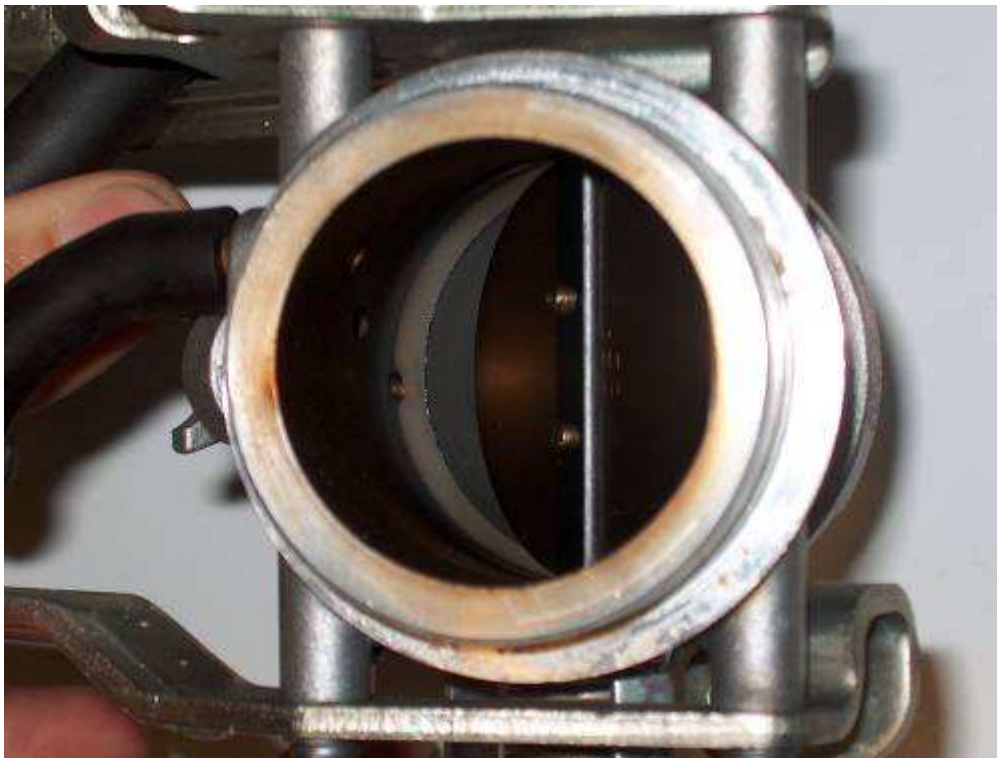
The following image shows significant deposits of unburnt fuel residue in the air duct: with the throttle closed, these deposits impede the injection system from delivering the correct air fuel mixture, compromising engine function at idle or at throttle lift-off and causing engine cut-out or irregular idling.

The throttle body must be cleaned with specific products for cleaning throttle bodies or carburetors.

Proceed as follows: with the throttle valve fully open, clean the duct with a normal cloth - do not use brushes or rotary brush attachments; never remove the throttle valves from the body.

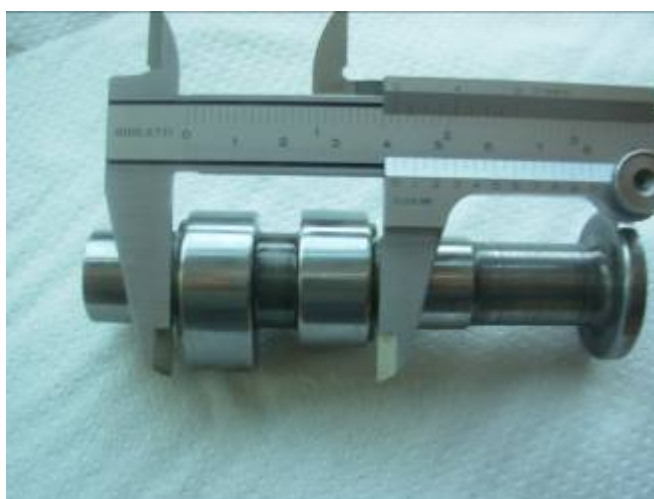
Before fitting the camshaft, you are kindly requested to check the dimension indicated in the following photo:

If the dimension measured is 40.35 mm, the camshaft may be installed with no additional shim.

If the dimension measured is 39.35 mm, a shim of the appropriate thickness must be added.

**the final endfloat must be between: 0.02 and 0.11 mm.**

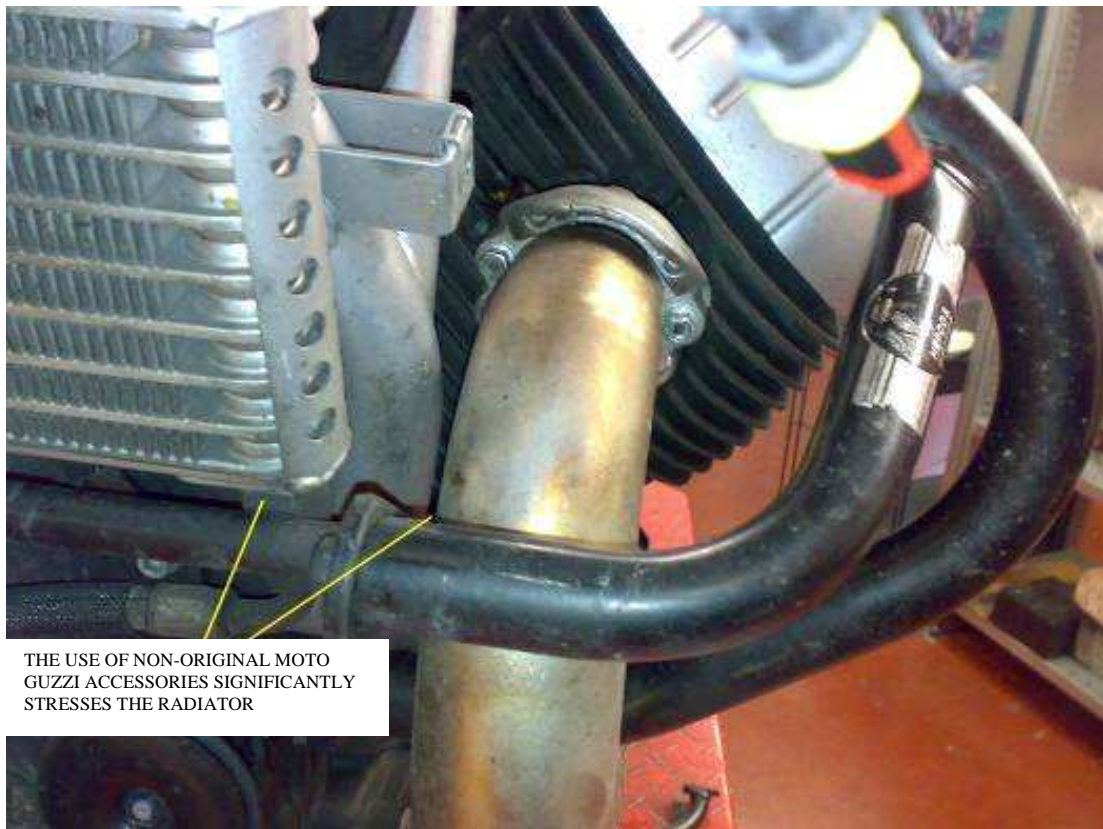
The following photos illustrate the problem more clearly. The engine guard installed here stresses the radiator and oil pipes. This is also transmitted to the screw fastening the frame to the engine, as the screw is not designed to sustain the additional strain.

THE USE OF NON-ORIGINAL MOTO GUZZI ACCESSORIES SIGNIFICANTLY STRESSES THE RADIATOR

Only install and recommend original Moto Guzzi accessories.

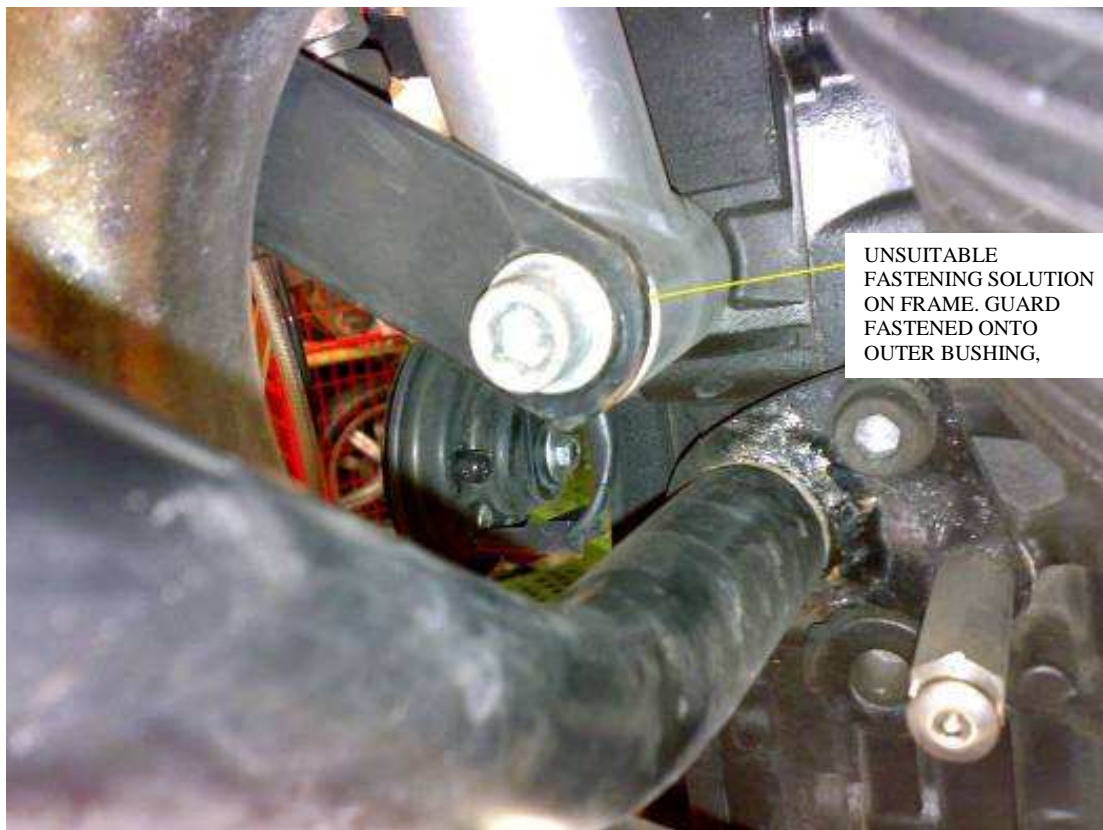
Clearly, this solution is **potentially dangerous** as it may lead to the failure of the mountings themselves.

UNSUITABLE FASTENING SOLUTION ON FRAME. GUARD FASTENED ONTO OUTER BUSHING,

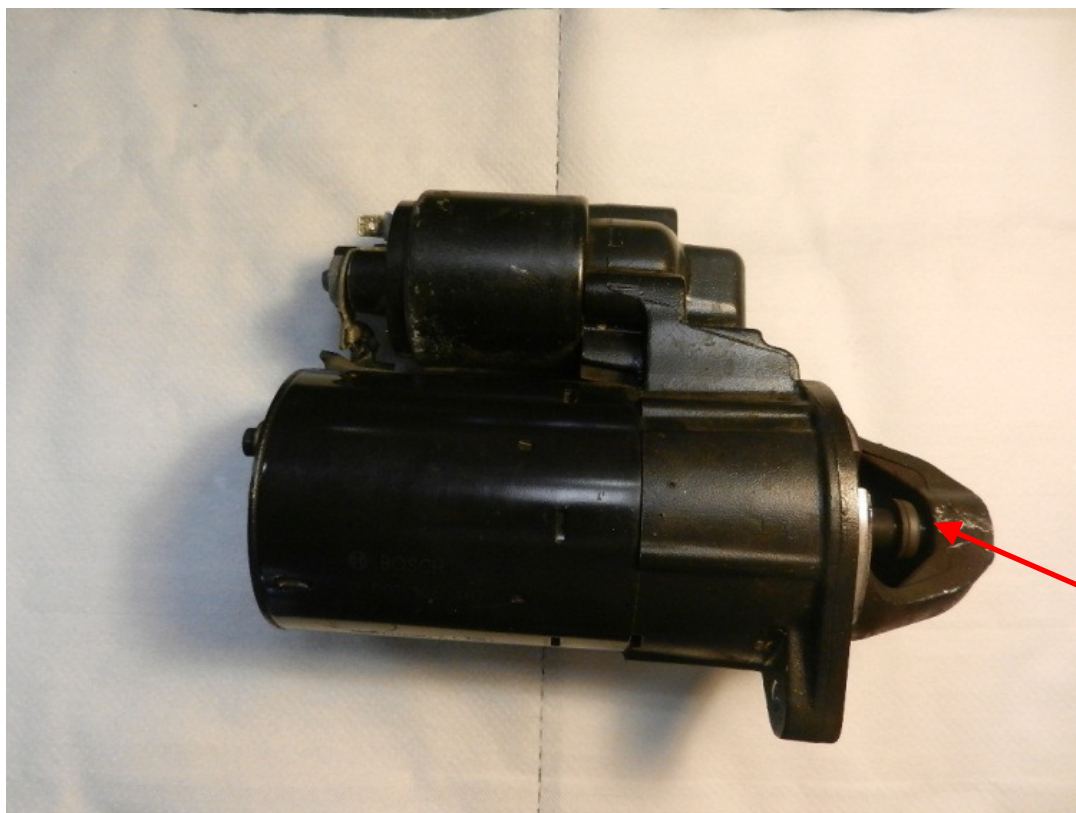
- Starter motor very dirty in flywheel engagement area

dirt

- Clean the mechanisms with WD40-P140 degreaser for mechanical systems and lubricate with AGIP GREASE MU2

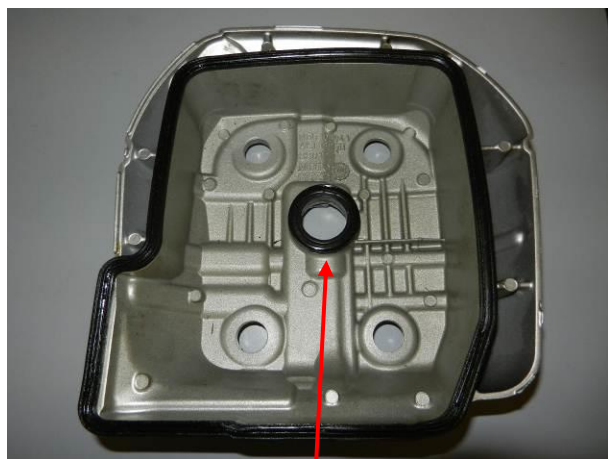
**OK**

To verify whether the vehicle can be modified with **kit A** remove the timing cover and check whether it is the floating type, which can be recognised by the presence of the circlip in the spark plug hole area:

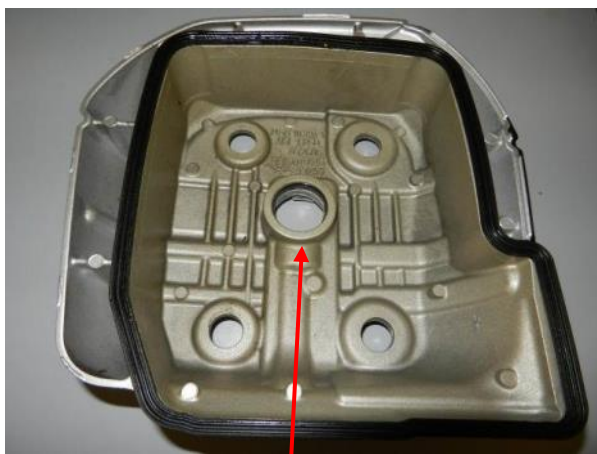
**OK**

To determine if the vehicle may be modified with **kit B or C**, remove the timing cover and check that it is a **NON**-floating type cover, which is identifiable by the absence of a circlip in the spark plug hole area:
