**TECHNICAL BULLETIN NUMBER 005-2009**

**MODEL: Stelvio 1200 NTX**

**SUBJECT: Wheels and knobbly tyres**

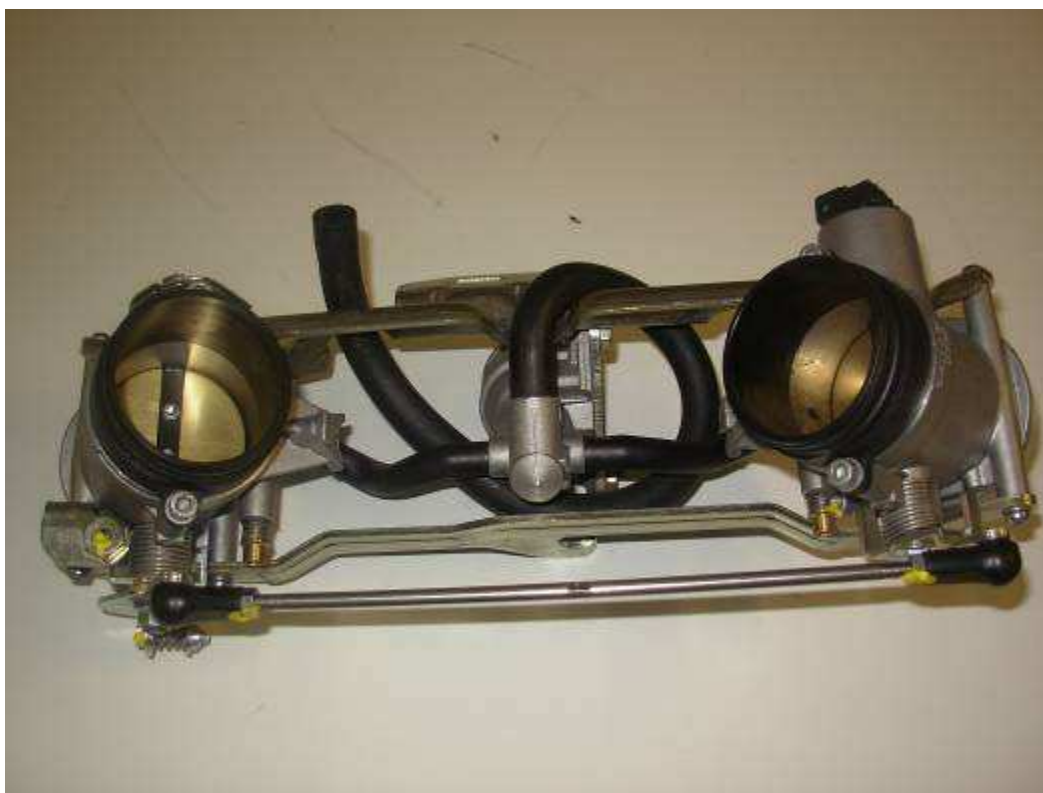
The following image shows significant deposits of unburnt fuel residue in the air duct: with the throttle closed, these deposits impede the injection system from delivering the correct air fuel mixture, compromising engine function at idle or at throttle lift-off and causing engine cut-out or irregular idling.

The throttle body must be cleaned with specific products for cleaning throttle bodies or carburetors.

Proceed as follows: with the throttle valve fully open, clean the duct with a normal cloth - do not use brushes or rotary brush attachments; never remove the throttle valves from the body.

**IMPORTANT:** cleaning the throttle body is recommended at each service interval indicated in the use and maintenance manual.

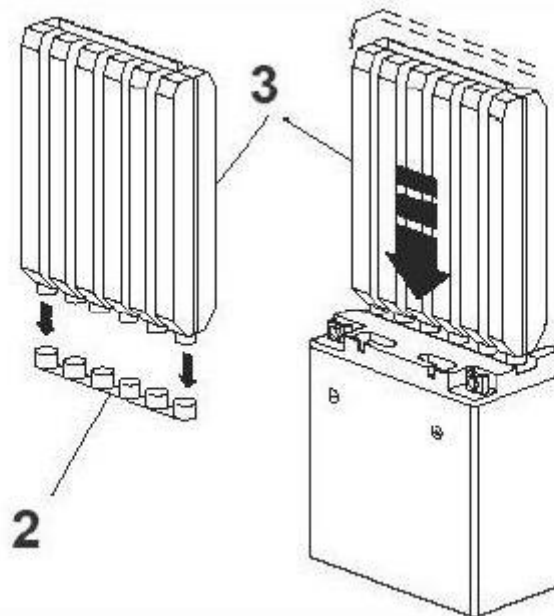
in the event of battery replacement under warranty on vehicles with low mileages where the cause “battery not retaining charge” was specified in the warranty request, the initial activation procedure described herein for the YUASA MF Maintenance Free batteries installed in models currently in production must be performed correctly.

- Place the battery on a flat surface.
- Remove the adhesive cell protection label.
- Select the container of acid.
- Remove the lid 2 from the container 3 (this lid will be reused after filling to seal the cells).
- Turn the container upside down vertically over the battery, with the six nozzles aligned correctly with the six battery cells.
- Press the container until its seals break. The fluid will start to fill the cells.

- Check that there are no air bubbles remaining in the cells; leave the fluid to drain into the cells for at least 20 min.
- If the air bubbles remain trapped in and case the fluid does not drain correctly from the container, tap the bottom of the container gently until fluid starts to drain into the cells. **Never remove the container from the battery, perforate or cut it to make the liquid flow more easily.**
- Ensure that the acid container is completely empty before removing.
- **Leave the battery to rest for at least 1 hour without fitting the cover on the six cells before starting the charging process. This step is extremely important to ensure correct battery performance and durability.**
